Education
Funding
Agency

Asbestos in schools: Where it may be located

**Departmental advice for school leaders,
governors, staff, local authorities, academy
trusts and charitable trusts**

February 2017

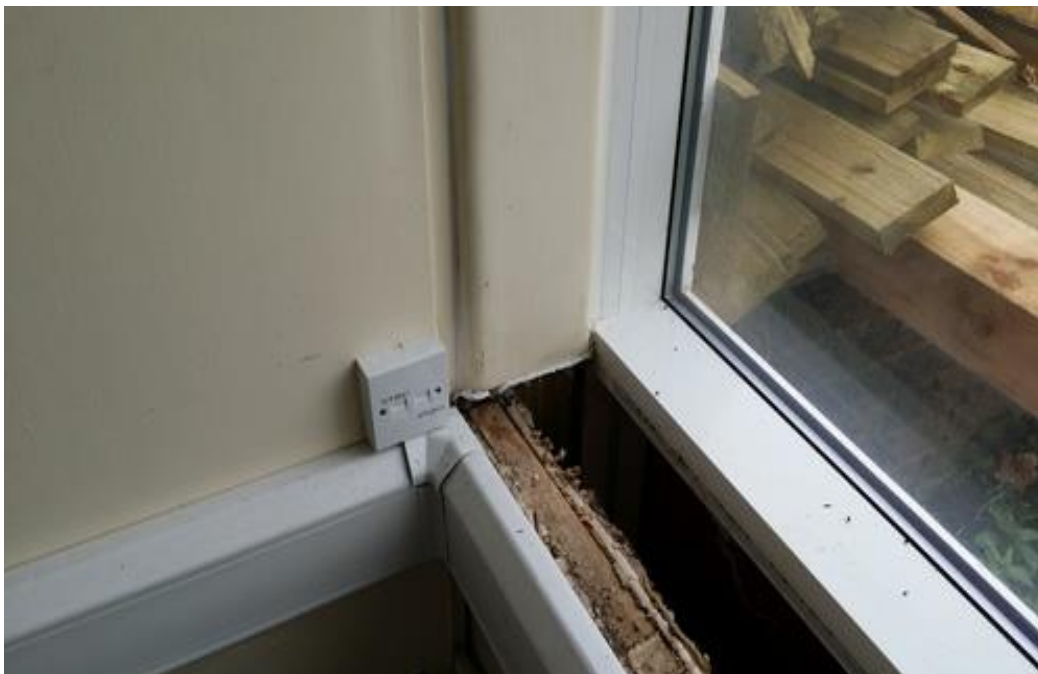
AIB panels beneath windows – AIB panel exposed below window board

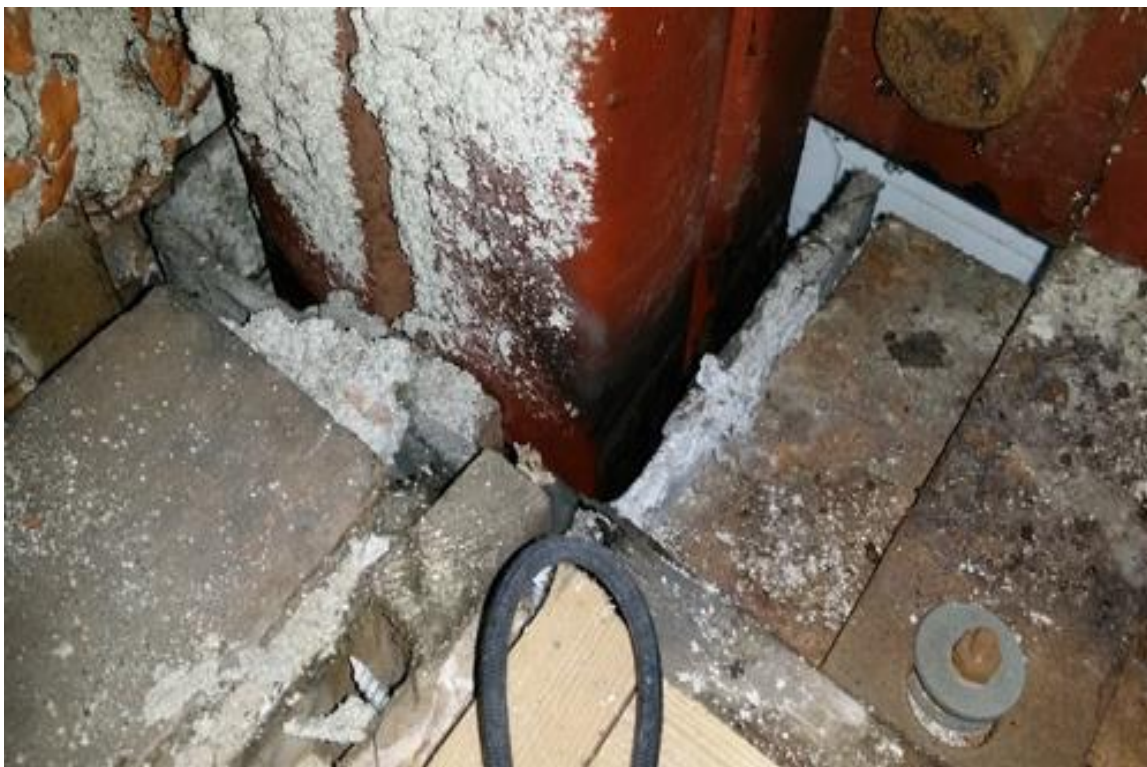
Base of a structural steel column in a classroom – exposed asbestos column linings

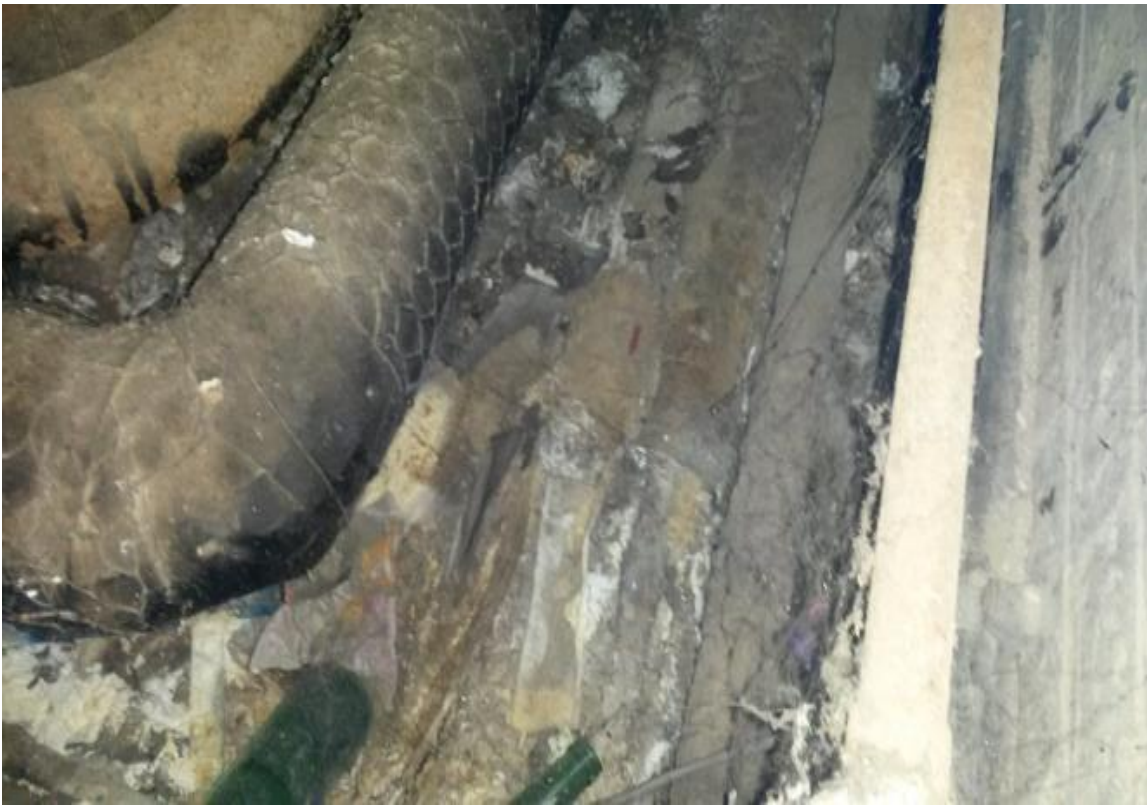
Dust containing asbestos - asbestos 'dust' pipe insulation below stage

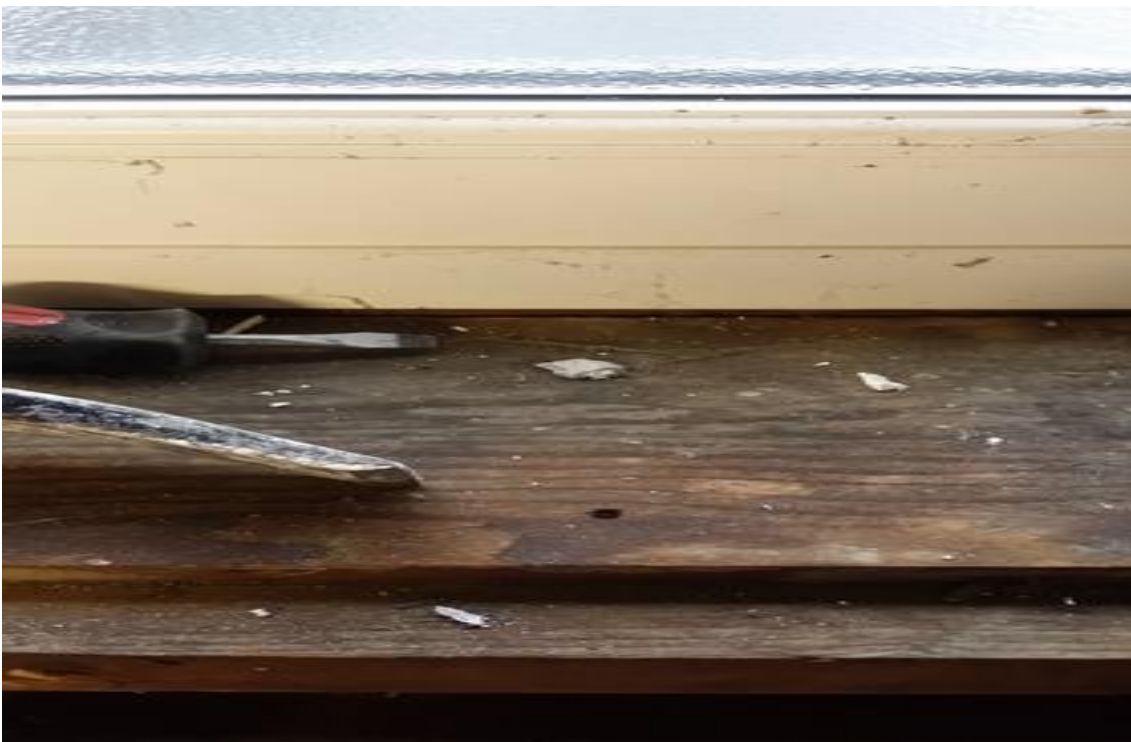
AIB cladding and asbestos debris – asbestos debris from AIB window surround cladding

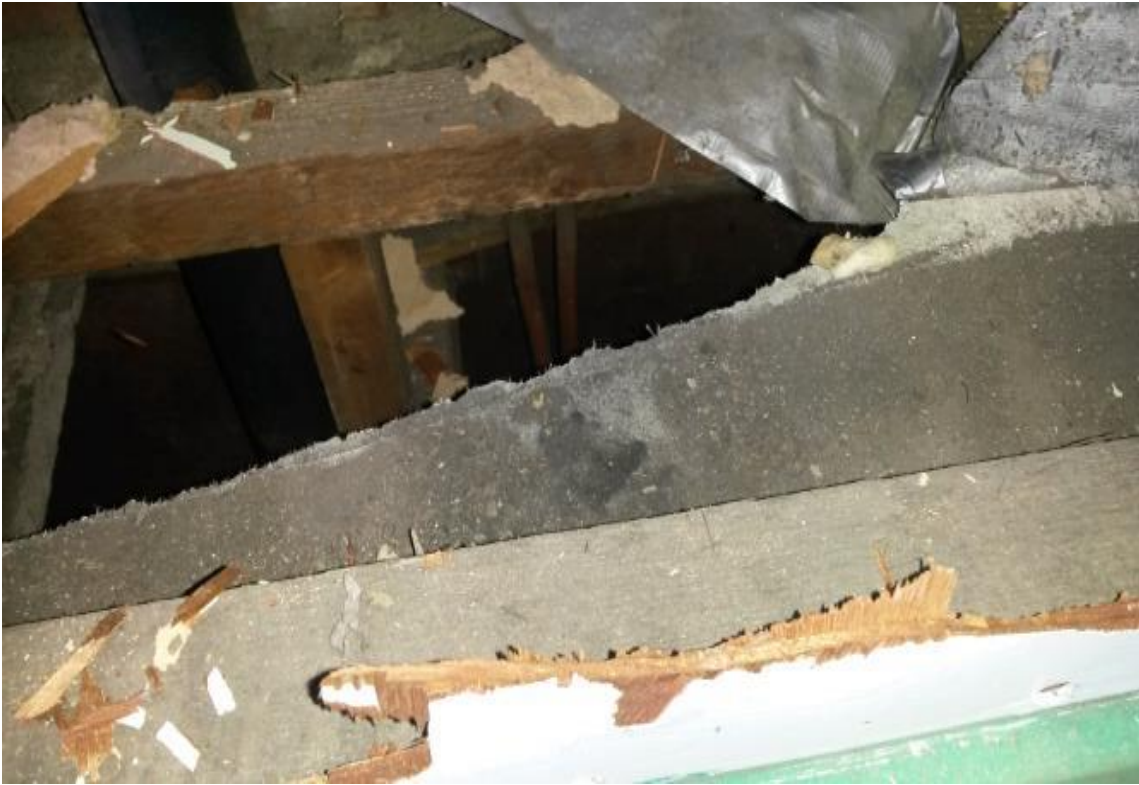
Damaged asbestos panelling – AIB base board to riser, historic damage

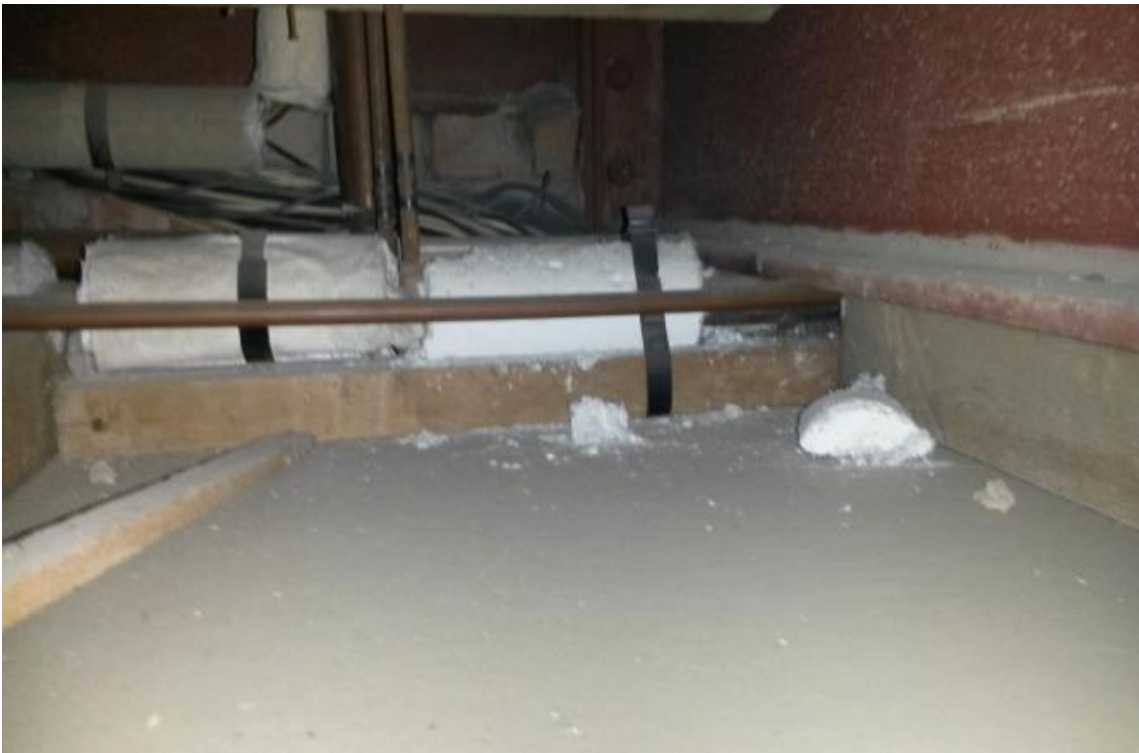
AIB debris in ceiling void of a school - insulation debris to back of non-asbestos suspended ceiling

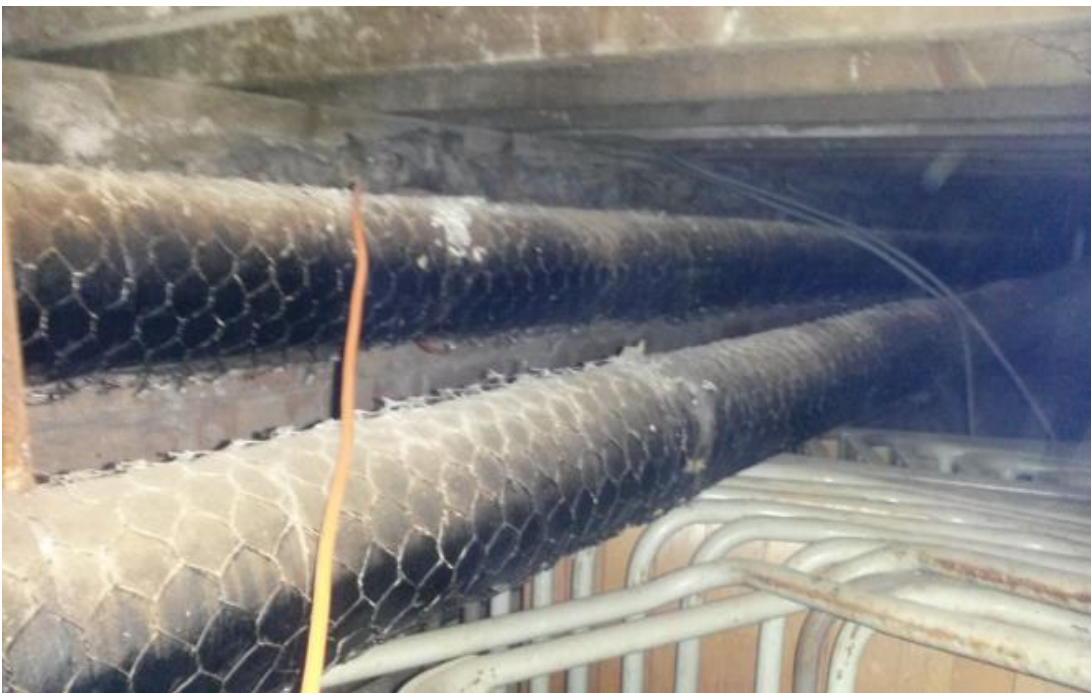
Asbestos lagging beneath floorboards

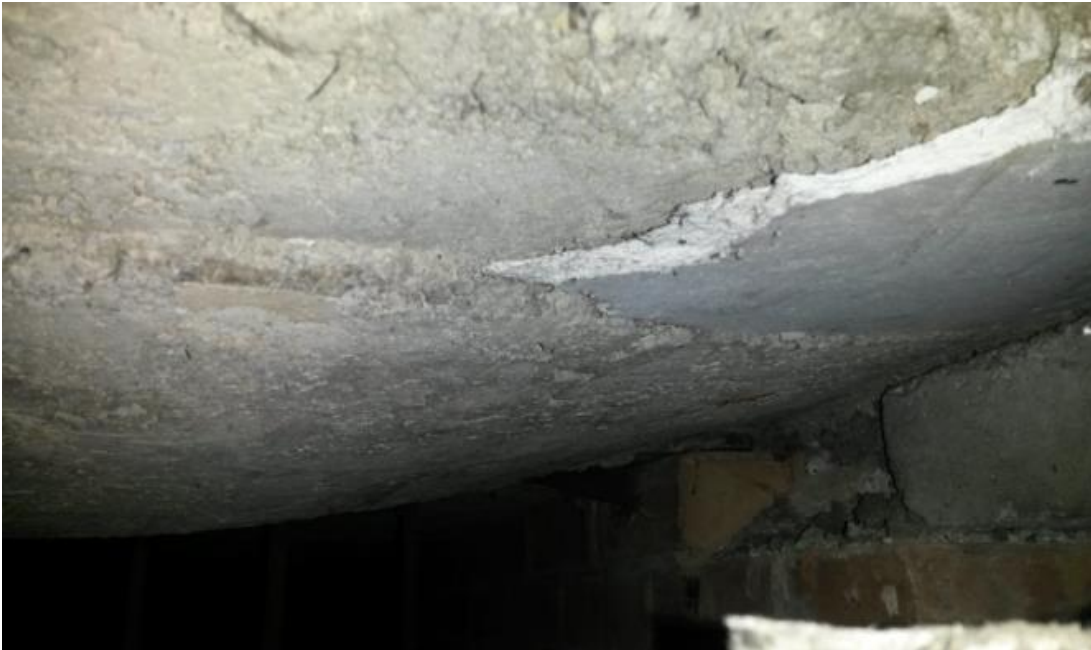
Sub floor heating ducts – insulation board shattering around duct hatches

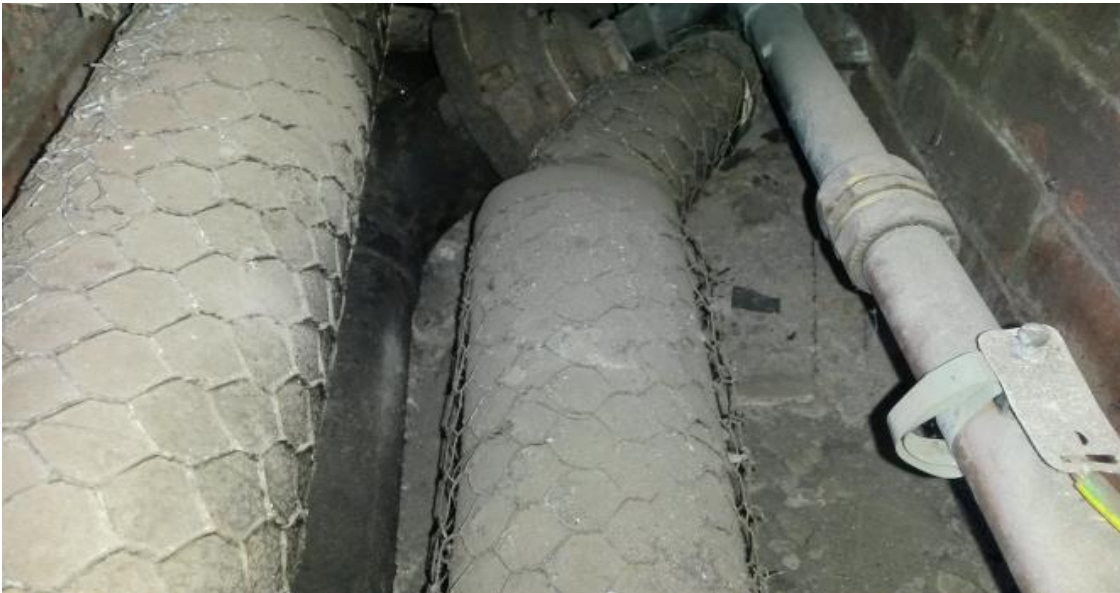
Asbestos in underground duct work- sub floor heating ducts, asbestos pipe insulation

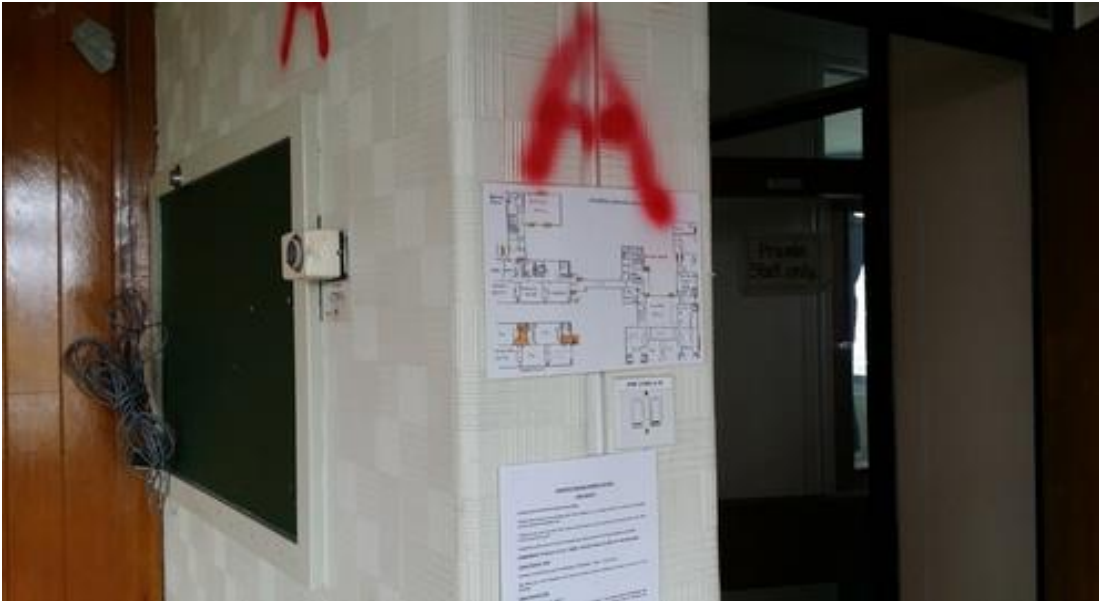
Moulded column cladding containing asbestos

Some moulded cladding for structural steel work can contain asbestos in a cement matrix. Fibres are released less easily, but as the columns can be free standing in classrooms the cladding can be damaged accidentally.

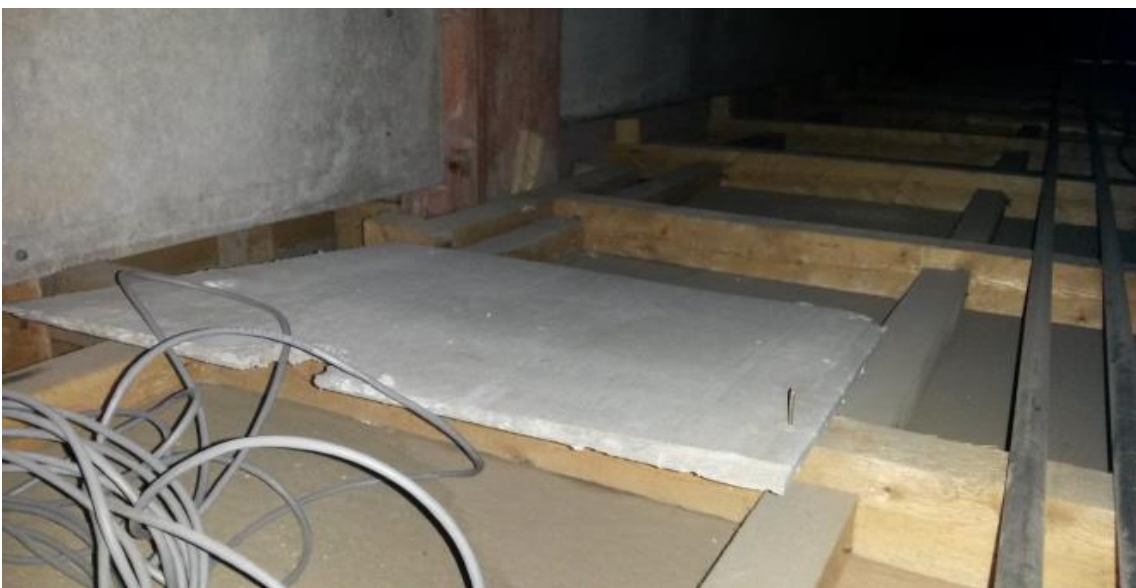
Asbestos firebreak in ceiling void of a school

Firebreaks in ceiling voids can be made of asbestos cloth; seals on boilers and pipe work can be made of asbestos ropes and yarns.

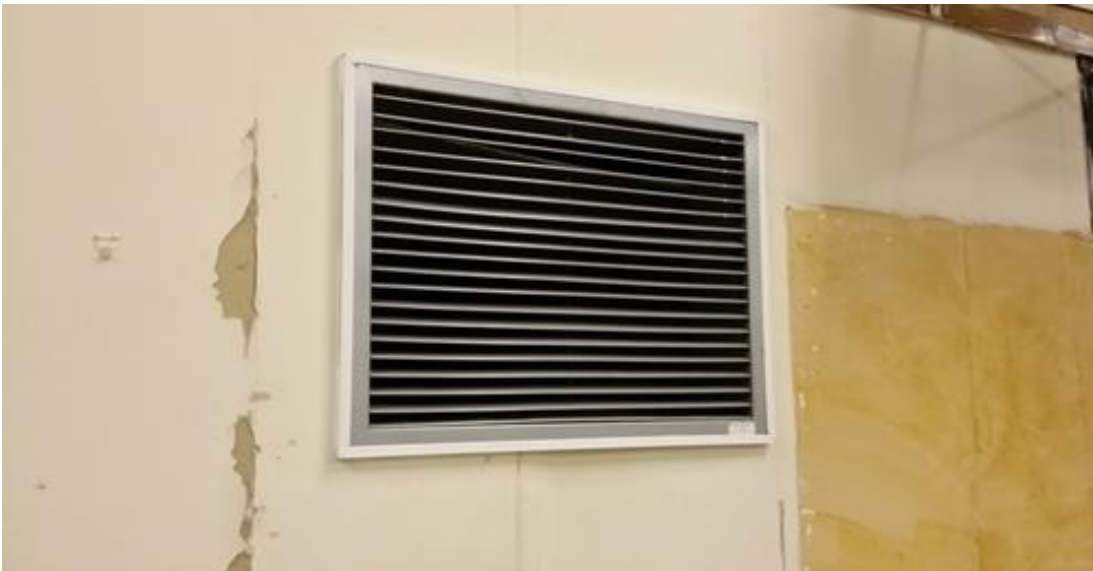
Warm air cabinet heater – AIB Unit 'surround' and internals

Warm air cabinet heaters were first developed in the 1950s and became one of the most popular forms of heating in schools. The heating elements and fans are contained within large cabinets that can either be free standing on the floor of the room or concealed within a wall. The cabinets were constructed on site, usually of a timber frame, and were typically lined with unsealed AIB.

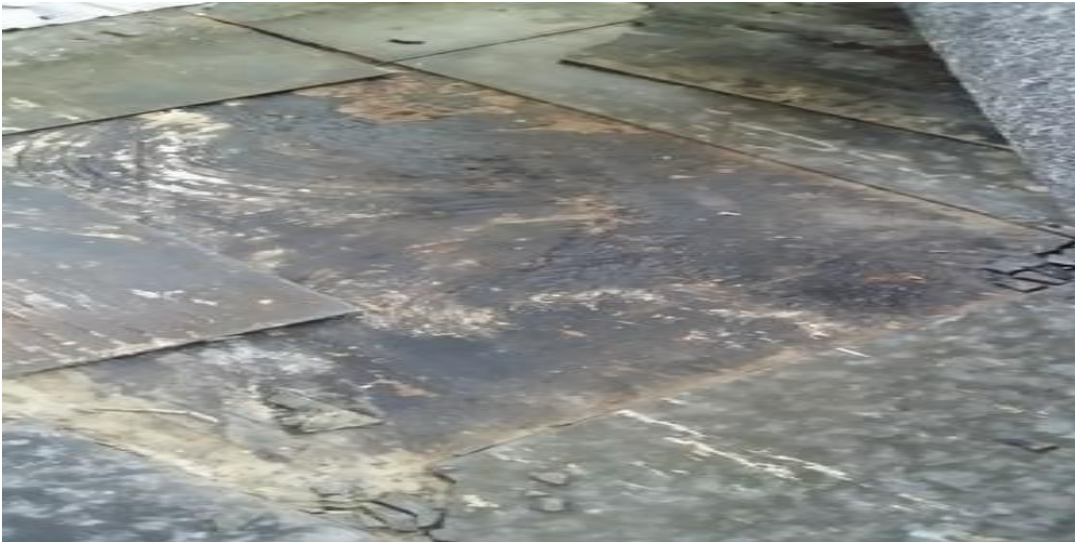
Floor tile adhesive (Bitumen) containing asbestos

Bitumen mastics and adhesives were used for floor tiles, wall coverings, damp proof courses and sink pads. The asbestos fibres are held firmly by the bitumen matrix.

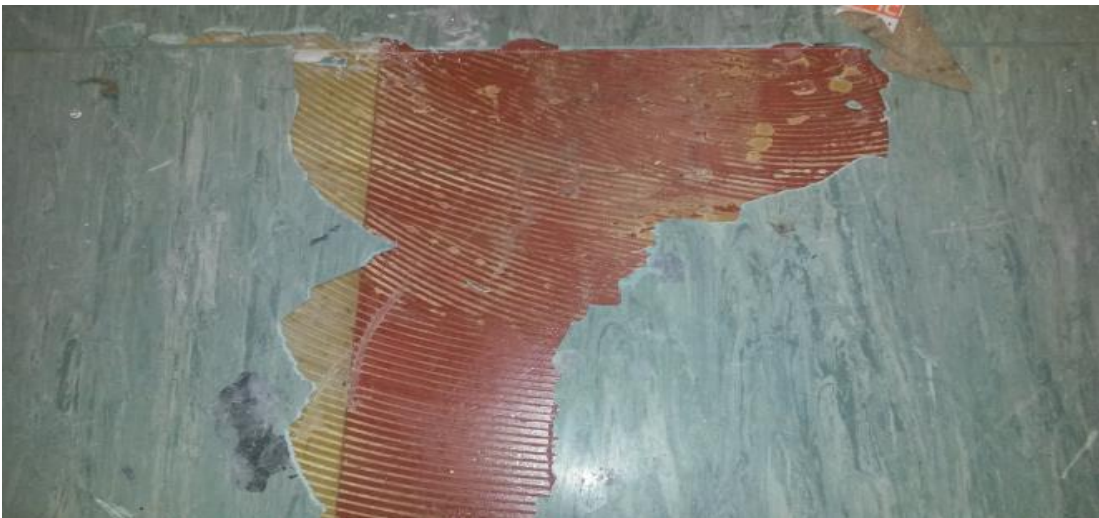
Badly worn asbestos floor tiles in a school corridor – damaged floor tiles and adhesive below corridor carpet

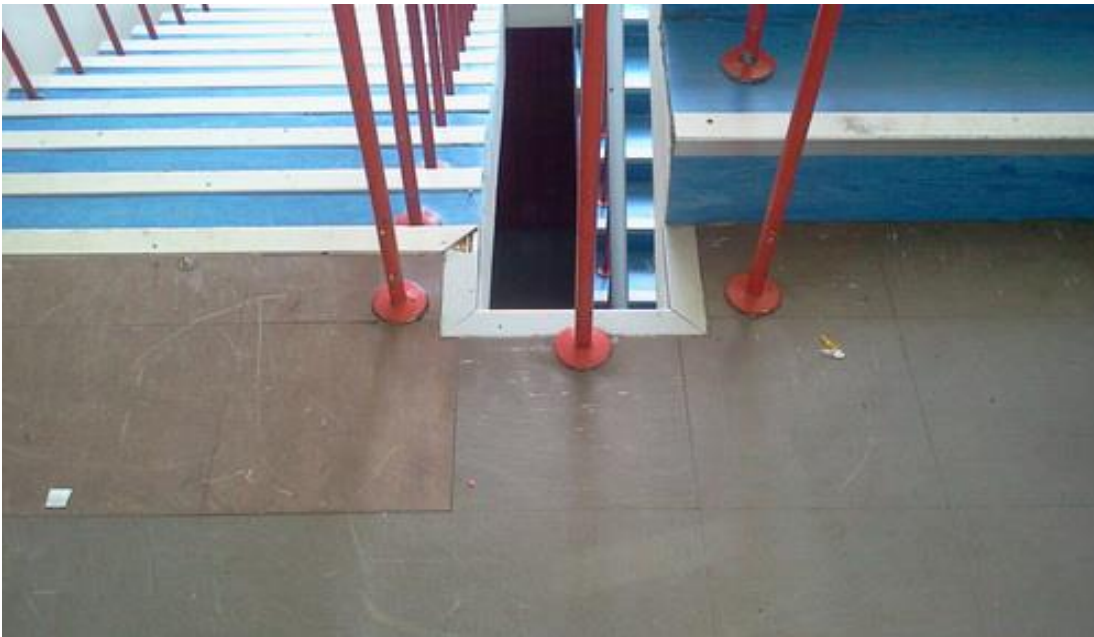
Asbestos containing stair nosing

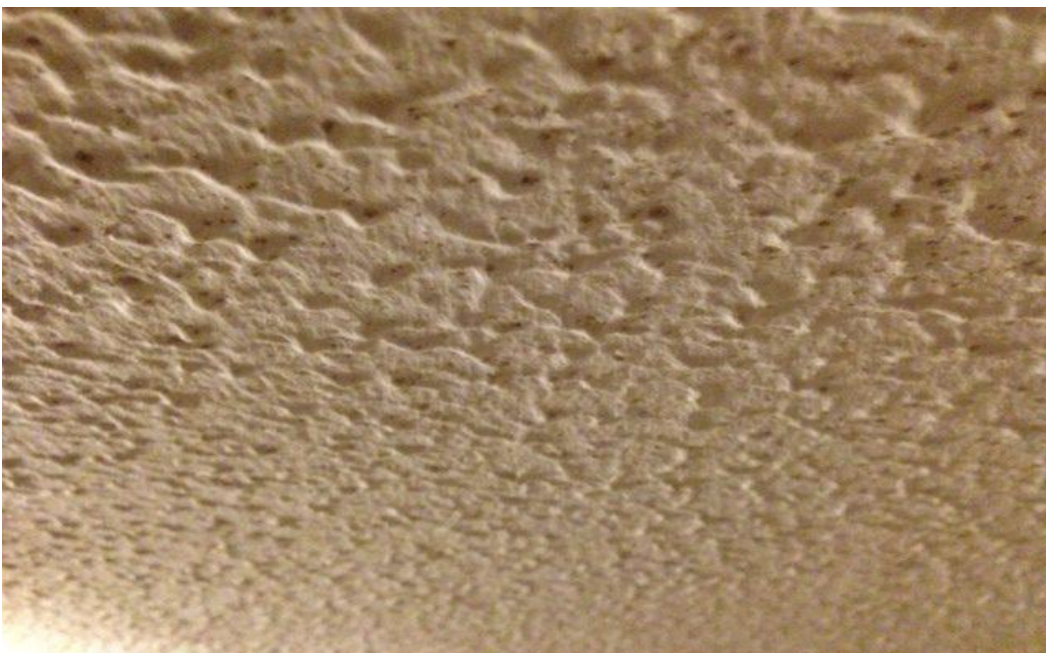
Sprayed asbestos on the ceiling of a school corridor – sprayed asbestos above suspended ceiling

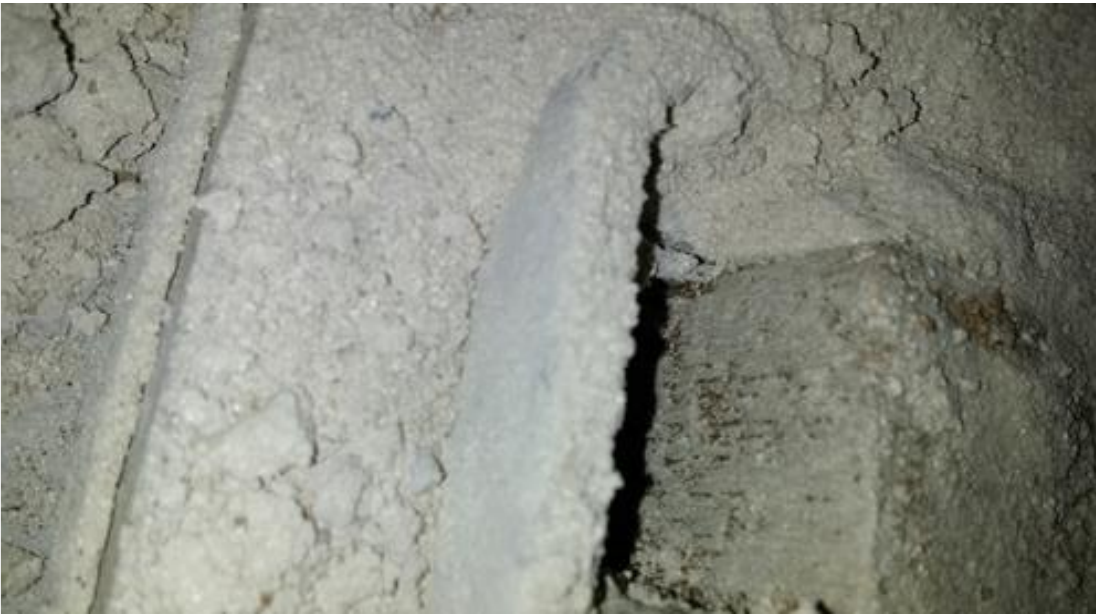
Sprayed asbestos on a column of system built school- CLASP built steel framed school with fully 'lagged' frame

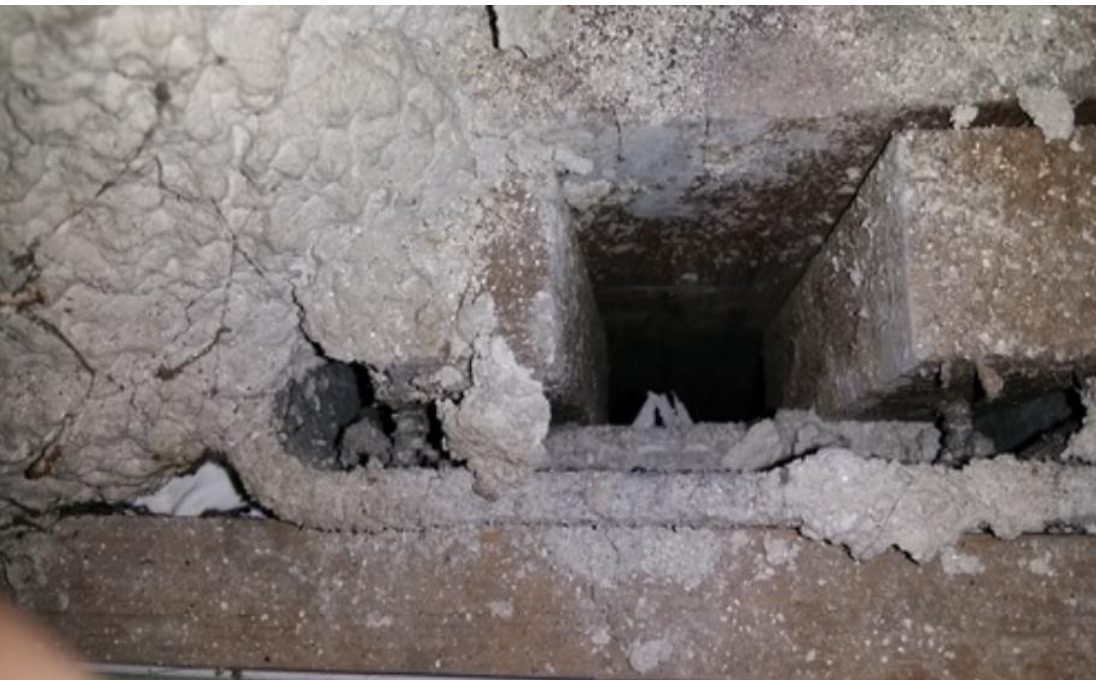
Sprayed asbestos on a column of system built school – lining behind cement wall end and column linings

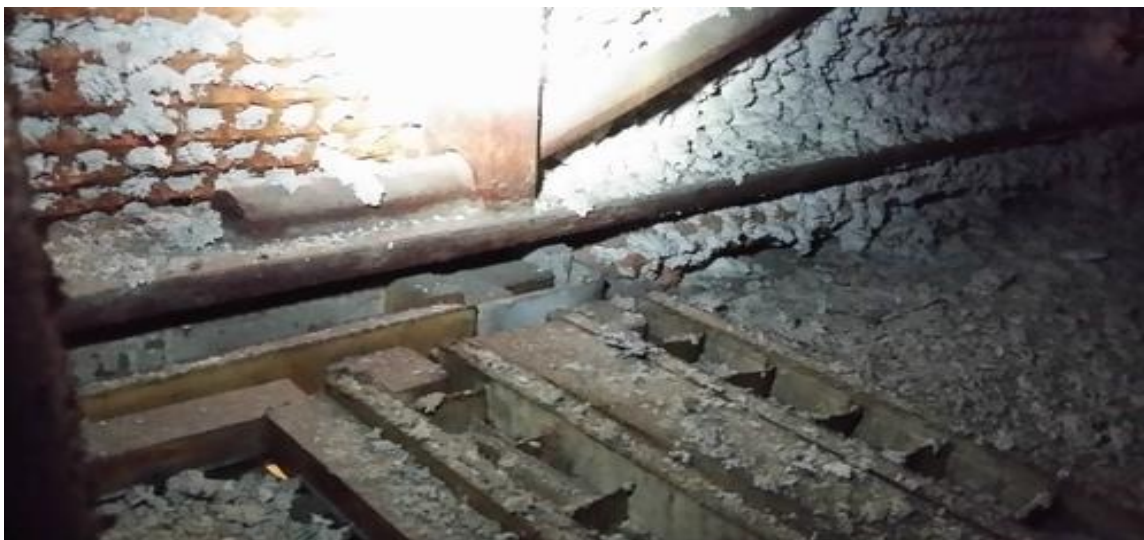
Sprayed asbestos on a column of system built school – Steel frame, wrapped in perforated steel with blown asbestos (note pattern on top left)

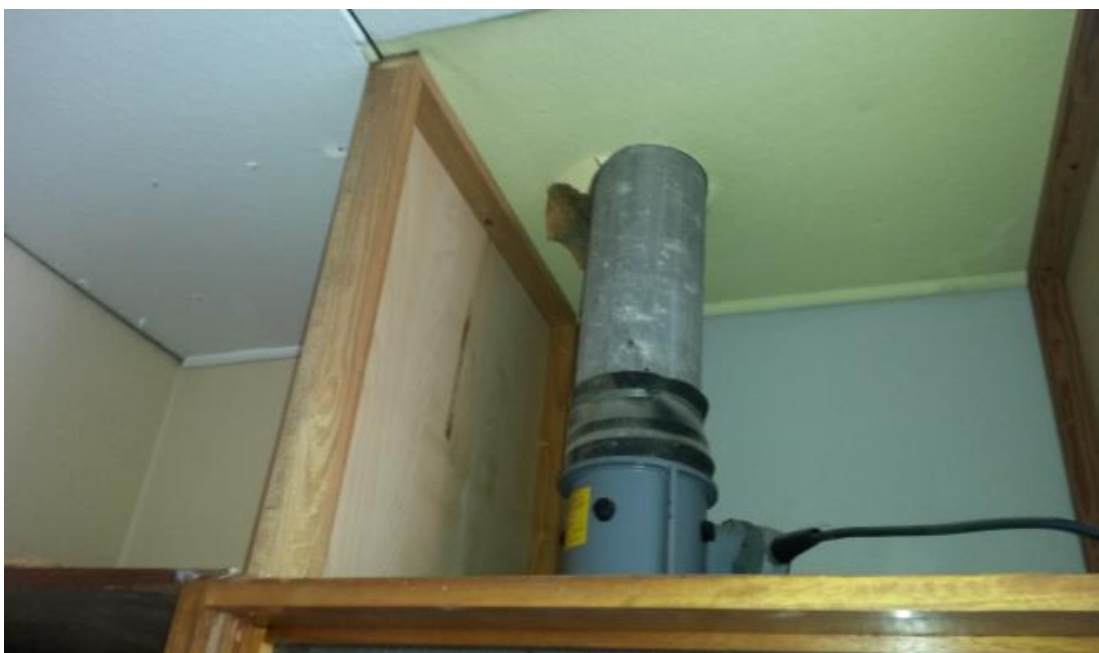
Asbestos cement fume cupboard – cement flue above fume cabinet
